ENGINEER'S REPORT

The Town of Goffstown (the Town) is located in Hillsborough County, New Hampshire. It is a community of roughly 17,651 people (2010 Census), with a square mileage of 37.5. This engineering report provides an evaluation of the Town's bathing facility and swimming pool at Barnard Park, and provides recommendations for improvements based on Weston & Sampson's site evaluation.

Weston & Sampson was retained to a perform professional engineering and compliance evaluation, and for planning services in connection with the Town's Pool Facility at Barnard Park. Our scope of services included the following:

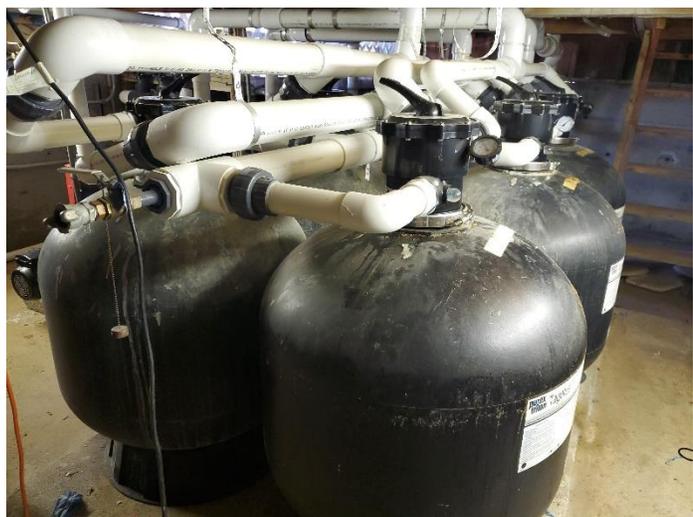
Figure 2 – High Rate Sand Filters

The six (6) current filter(s) and filter sand are relatively new and still in workable condition. The pool staff has provided the proper care and maintenance to prolong the filters lifespan and keep them running. The staff replaced the filters sand in 2016.

Another challenge in the mechanical area is backwashing. Occasionally when backwashing the filters some sand ends up at the bottom of the pool. This could be due to a cracked lateral in the bottom of the filter.

- At a minimum the filter laterals should be inspected.
- It is highly recommended that a pH regulating device be installed.
- It is highly recommended that a chemical controller be installed, to operate the chlorination and pH metering pumps.
- An auto fill line through an air gap should be installed.
- It is highly recommended that the main drain grates be replaced to comply with VGB.
- Pool walls need to be structurally assessed for structural integrity.
- To improve the efficiency of the filter pumps it is recommended that Variable Frequency Drives (VFDs) are installed.
- Repair skimmer boxes and sections of the pool wall to prevent further leaks.

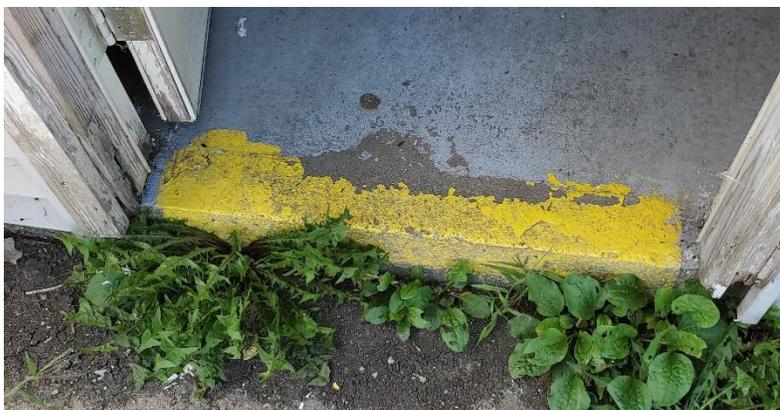
Figure 3 – Entrance to the Women's Bathroom

The pool deck is roughly 3-inches lower than the bathing facility. This change in level does not allow patron requiring ADA accessibility access to the restrooms or showers.

- Portions of the deck need to be relevelled to keep the changes in vertical height less than ¼-in.
- Create ramps at all bathhouse entry points to grant proper ADA access to the facility.
- The perimeter fence should be replaced with one that does not have openings exceeding 1.75-inches.
- The pool rules sign should be updated to include all required language.
- Update the bathing facility to include the required number of water closets, urinals, lavatories, and showers and to include ADA accessible showers.
- Update the bathing facility to meet code requirements for ventilation.
- Operating instructions need to be kept near the filtration equipment.
- All pumps need to have a vacuum and pressure gage installed.
- Flow meter needs to be reinstalled to manufacturers recommended dimensions to allow for proper calibration and flow measurements.

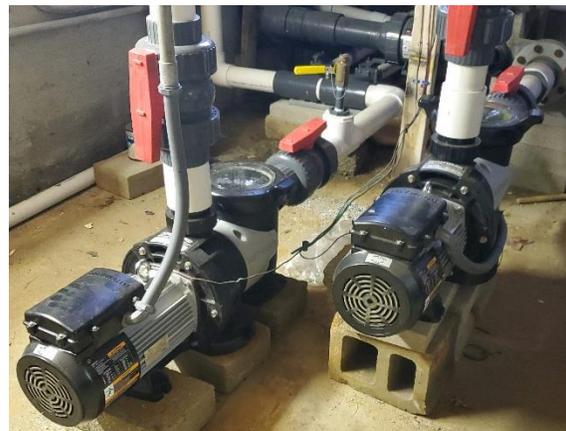
Figure 5 – Missing Pressure Gauges on Pumps

Currently there are no vacuum or effluent pressure gauges found on either of the pumps.
